# Manhole Inspection Summary

Manhole # S23II1035MH

Insp Date: **11/27/06 10:48 AM**

**Location** Address: **1304 MEDFIELD AVE**

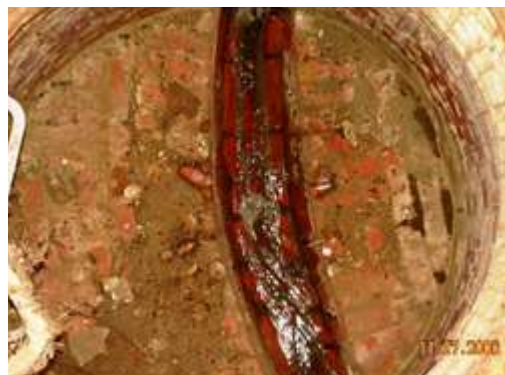
Top View

**Bench** ☒ Exists Material: **Brick** ☐ Parged ☒ **Debris** (not Condition related)

Bench debris.

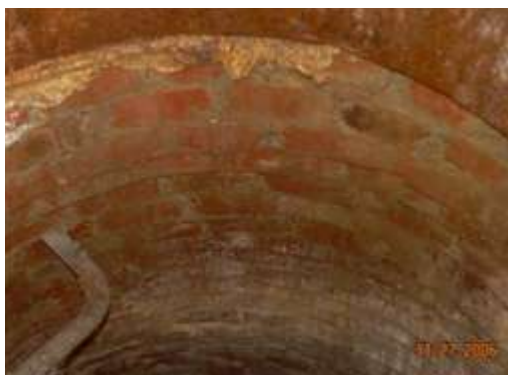
Defect

Infiltration: ☐ None ☒ **Joint** ☐ Cracks ☒ **Mortar** ☐ Roots ☐ Wall

Adjustment deterioration and infiltration.

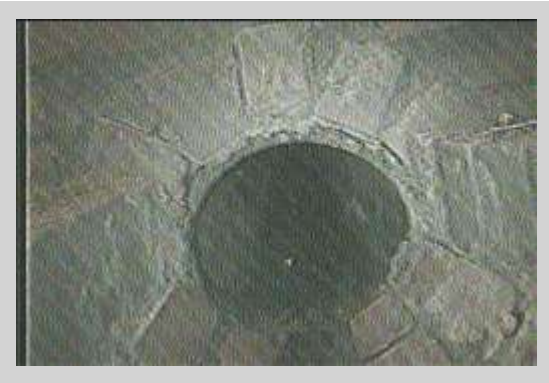
### 8 in. Circular Gravity Sewer Pipe Out @ 12 O'Clock

Infiltration: **Evidence** Pipe Seal Cond: **Unknown**

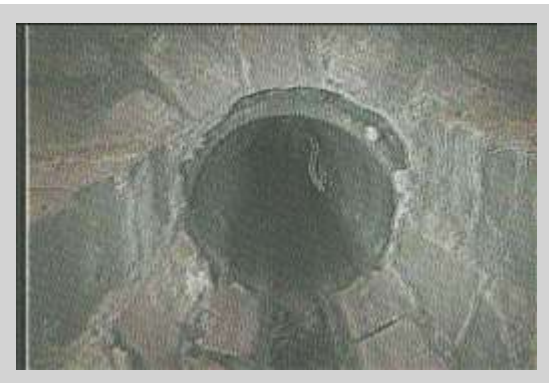
### 8 in. Circular Gravity Sewer Pipe In @ 5 O'Clock

Comments **The I5 pipe seal is not flush to the pipe.**

Infiltration: **Evidence** Pipe Seal Cond: **Unknown**
